Quality Monitoring Improved & Cleaning Time Reduced (Powdered Therapeutic Nutrition)

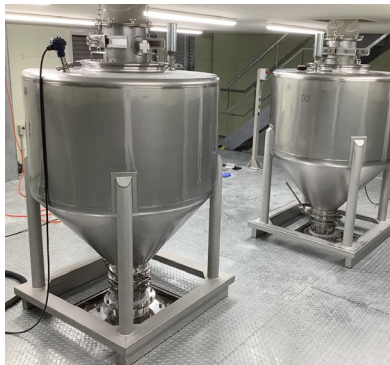
Steel buffer tank/hopper

The plant used 840L steel buffer tanks that often encountered clogging, bridging and ratholing problems that were difficult to clear.

There was no product flow visibility to alert the operators to bridging or ratholing. These large steel tanks also required cleaning once per month which involved a difficult removal, relocation and replacement process that took four days and multiple staff.

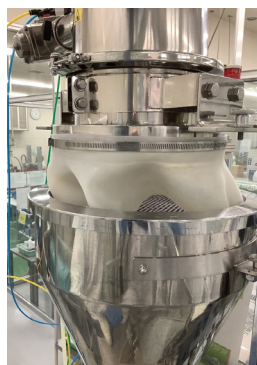
Hopper connection under Piab vacuum conveyor

In addition to the buffer tanks, the company had a problem with dust leaking from a hopper connection under a Piab vacuum conveyor. The powdered product was being fed into the hopper via freefall with just a short, one-ended clamped connector surrounding the product flow. This meant the product was not fully contained and leaked into the production area causing a health and safety concern.

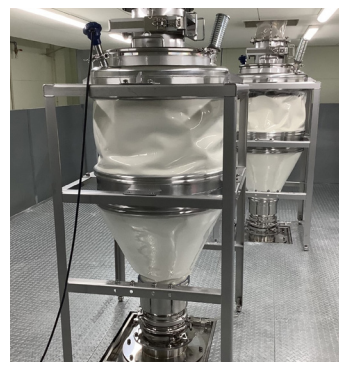
BFM® two-part hopper solution with transparent Seeflex O40E

Local BFM® fitting distributor, JP Next, designed a two-piece hopper system using BFM®'s durable, transparent Seeflex O40E polyurethane. The customer now has constant visibility of the product flow and the anti-static nature of the material has helped reduce powder adhering to the walls of the hopper. Any blockages can be easily seen and manually remedied by massaging the flexible walls of the tapered connector to free up the product flow.

Cleaning time has also been significantly reduced as it now requires only one person who can easily remove and transport the flexible connectors to the cleaning area.

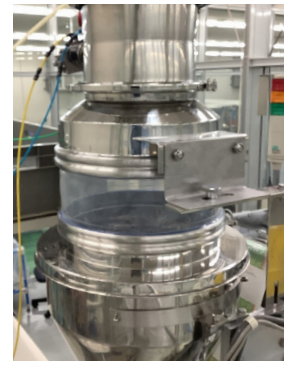
Hopper connection under Piab vacuum conveyor

On the other hopper connection, a BLUEBAND™ connector system was installed to fully encase the gravity feed powder providing a 100% sealed system, improving hygiene for both product and staff.
