# Dust and Downtime Issues Solved for Minerals Processor (Calcium Carbonate)

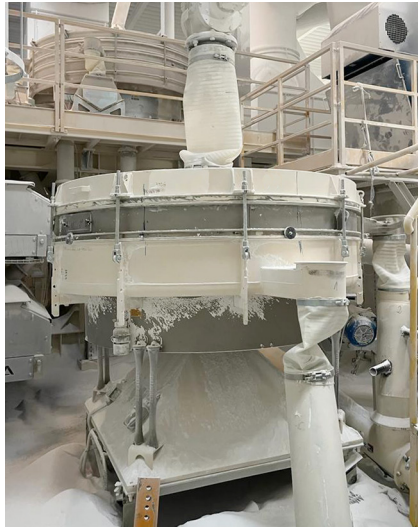
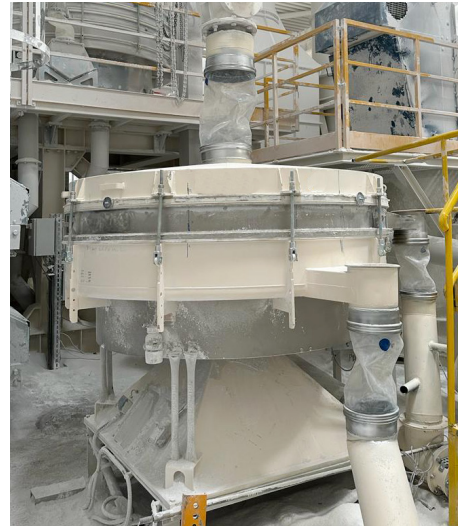
The customer had a lot of dust, material loss and downtime related problems on the sifters in the initial part of their process, after crushing and before milling. The old flexible connectors leaked constantly and they wore out extremely fast, not even lasting one month. Product spilled out and piled up around the sifters requiring frequent clean-up.

The maintenance team found the replacement of the worn connectors extremely time consuming because they were all different sizes had to be measured and cut to length. Then, to install the connectors, they were fastened via screwed hose clamps requiring considerable manual adjustment in difficult locations.

Local BFM® fitting distributor, Rocom, recommended installing BFM® fitting's durable Seeflex O40E connector systems on each sifter inlet and outlet. They also suggested standardizing all diameters and connection lengths to be the same for ease of maintenance and inventory control.

The result in terms of productivity uplift has been dramatic. In the 5 months since the initial installation, the plant has experienced zero downtime for connector replacement as the initial connectors are still going strong. When they do require changing, the staff are now confident each connector changeover will take less than 30 seconds, with stock always immediately on hand no matter which connector needs replacing.

There has also been no dust leakage from the connector transitions so the overall plant environment is cleaner.
